**DEPARTMENT OF DEFENCE  
DEFENCE SCIENCE AND TECHNOLOGY ORGANISATION  
AERONAUTICAL RESEARCH LABORATORIES**

**STRUCTURES REPORT 389**

**BRITTLE FRACTURE OF CRASH HELMETS**

FEBRUARY, 1982

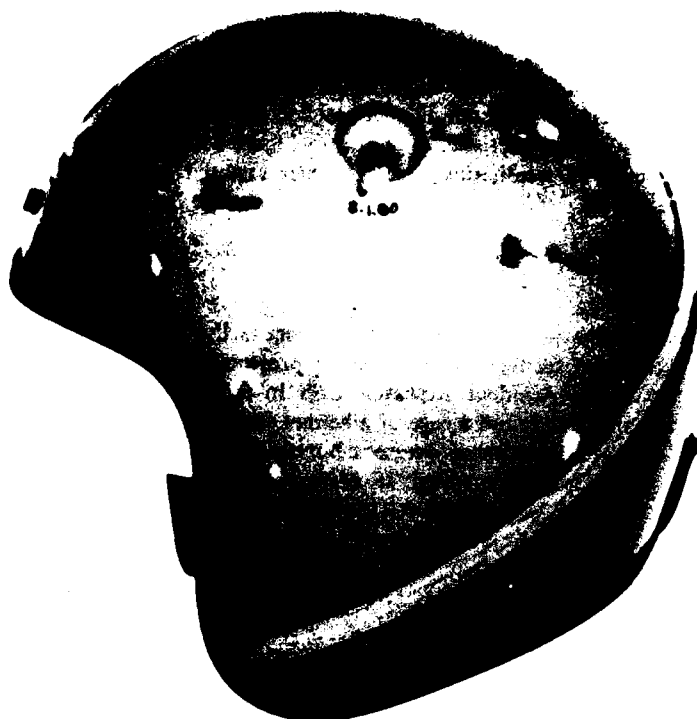
Three specimens of seven models of helmets, including three with polycarbonate shells, were exposed on a north facing roof at ARL. Two of each model were tested at intervals and after 12 months no deterioration was detected (as indicated by the standard penetration test of ASI698). After eighteen months one helmet cracked around an impact point with the crack running through a previous impact site, as shown in Figure 12. It is considered that this shows deterioration as a result of weathering, but the other exposed helmets must be tested before conclusions can be drawn.

8. One of several different types of helmet exposed to the weather showed some signs of embrittlement, but tests are not yet complete.

**FIG. 12 POLYCARBONATE HELMET AFTER 18 MONTHS EXPOSURE TO WEATHER.  
DAMAGE CAUSED BY PENETRATION. EXPOSURE COMMENCED ON 13.6.79.  
DATE OF TEST SHOWN ADJACENT TO IMPACT.**
